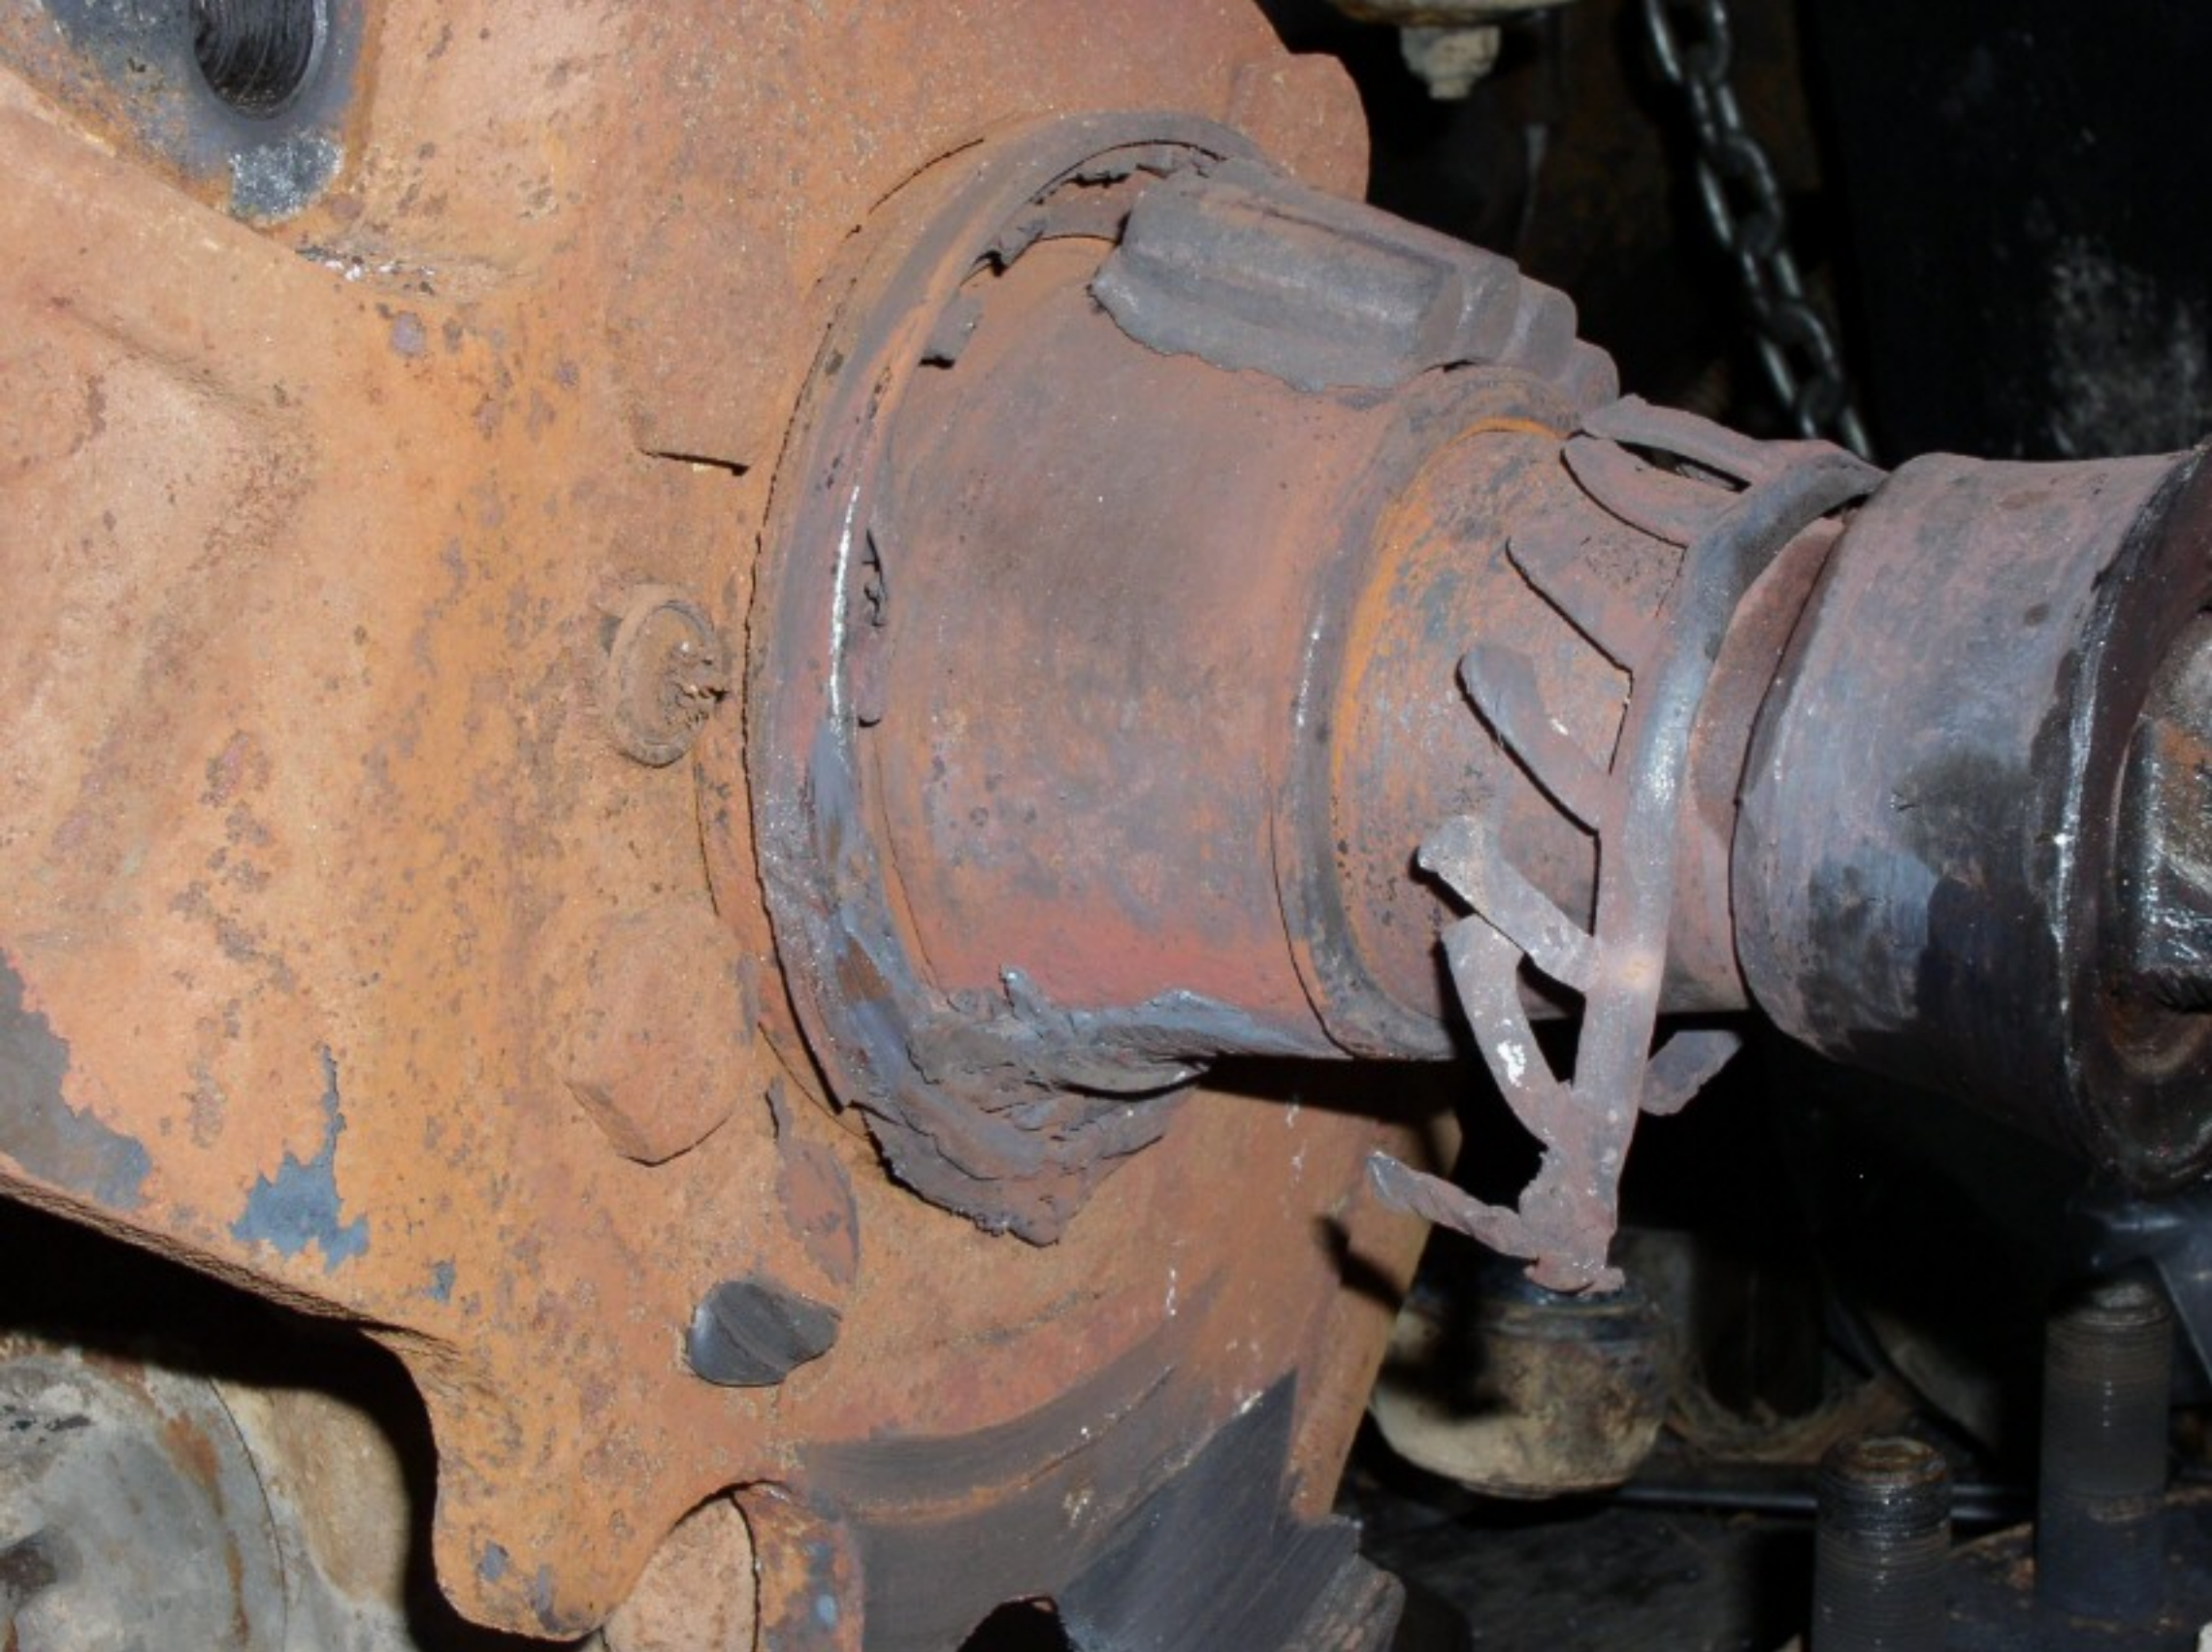
VEH Photo #43 - Right Side Tag-Axle Spindle With Torn and Distorted Bearing Cage
